# Packwood Lake Entrainment Study Status Report

Energy Northwest

August 14, 2007

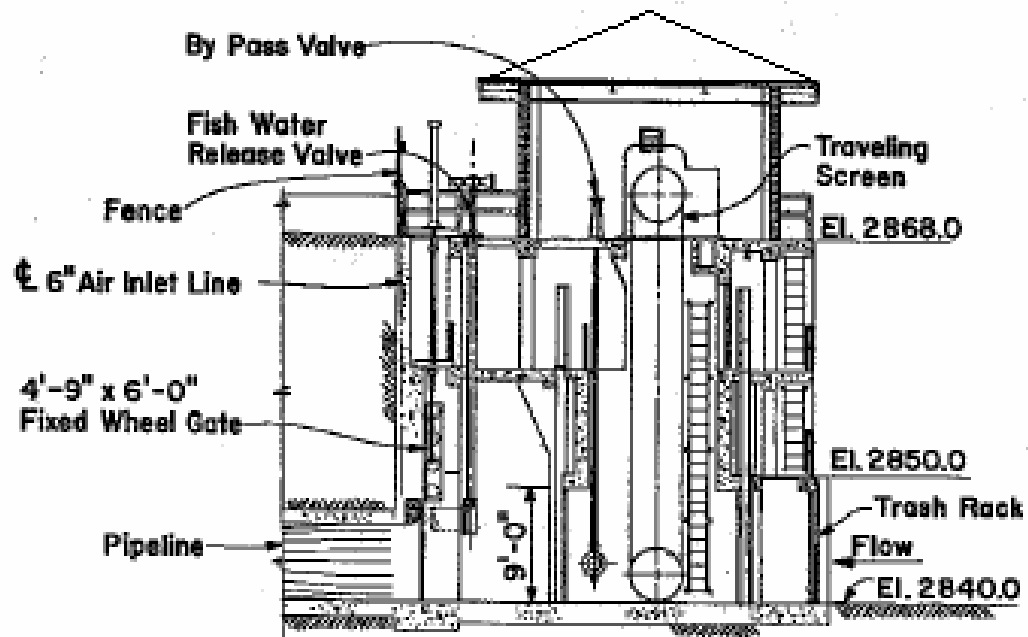
LONGITUDINAL SECTION

- Screen Mesh Size: 4.3 mm X 4.3 mm
- 2 Screens: Each 9 Ft Wide, Up to 28 Ft Tall
  - Base = 2840 ft MSEL
  - Area at Lake Elevation 2857 = 306 ft<sup>2</sup>
