**Engineering Needs for Access Routes Study
Draft Report
for
Energy Northwest's
Packwood Lake Hydroelectric Project
FERC No. 2244
Lewis County, Washington**

January 2007 Draft

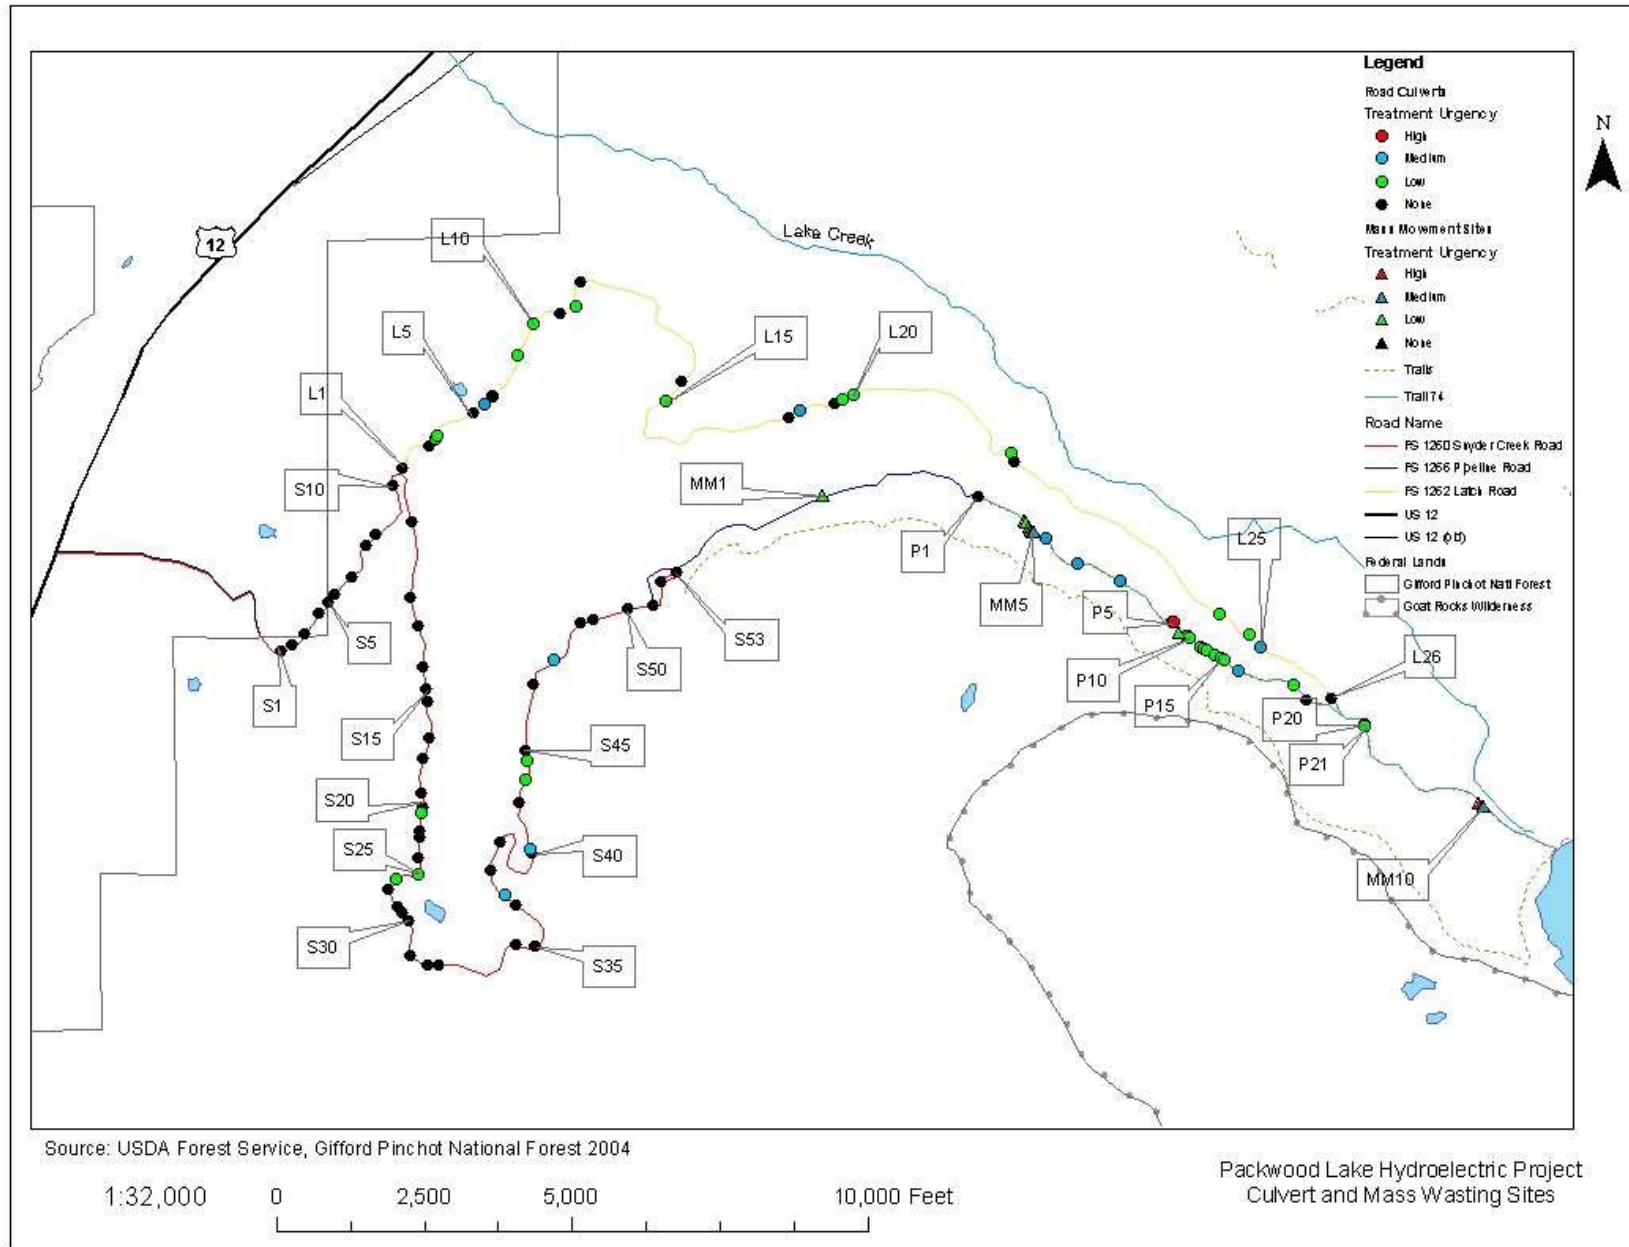
Figure 4.1 – Culverts and Mass Wasting Sites.

Note that culverts on Figure 4.1 are numbered by sequentially along each road. For example, S1 is Snyder Road culvert #1; L15 is Latch Road culvert #13. Mass wasting sites are numbered sequentially with a MM prefix, e.g., MM1, MM2. Numbers refer to the numbers in Appendix B.
