**Engineering Needs for Access Routes Study Report  
for  
Energy Northwest's  
Packwood Lake Hydroelectric Project  
FERC No. 2244  
Lewis County, Washington**

**May 2007**

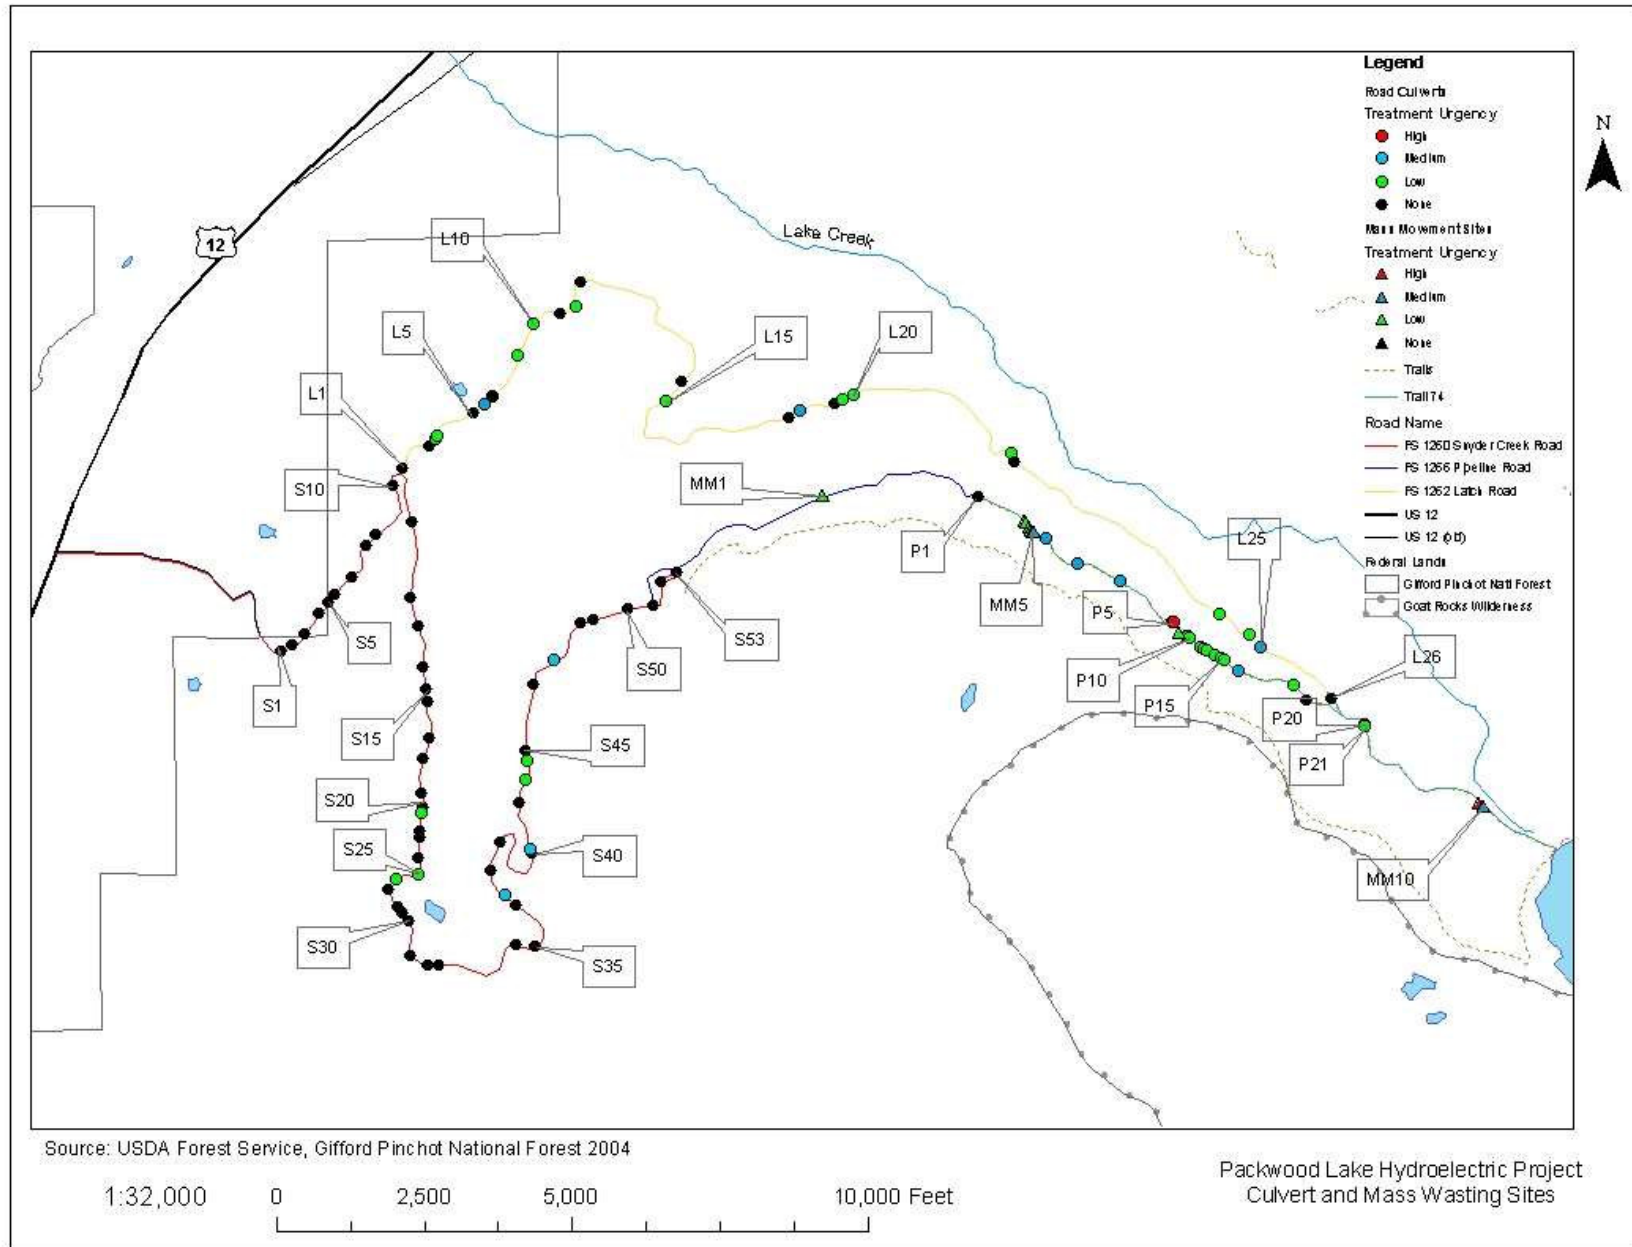
Figure 4.1 – Culverts and Mass Wasting Sites.

Note that culverts on Figure 4.1 are numbered by sequentially along each road. For example, S1 is Snyder Road culvert #1; L15 is Latch Road culvert #15. Mass wasting sites are numbered sequentially with a MM prefix, e.g., MM1, MM2. Numbers refer to the numbers in Appendix B.
