PRELIMINARY DRAFT
**HALL CREEK AND SNYDER CREEK
FISH PASSAGE**

Prepared for:
Energy Northwest

Prepared by:
EES Consulting

January 2005

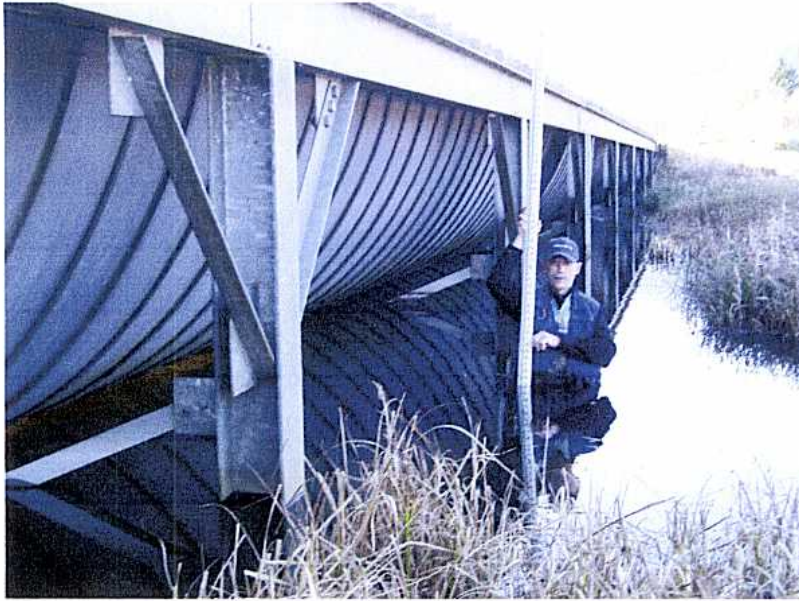
EES Consulting, Inc. surveyed passage at both the upstream and downstream side of the flume where it crosses Hall Creek. Upstream of the flume, Hall Creek enters a marsh and extends laterally for over 50 feet. Hall Creek passes under the flume in a 36-ft section where depths range between 2.5 ft and 3.1 ft. At the time of the survey the water surface elevation of Hall Creek was the same as the bottom of the flume. The calculated area under the flume at this location was approximately 100 ft², (36 ft in width \times average depth of 2.8 ft). Even if the water depth were to increase so that it backed up onto the flume, there would still be 100 ft² of passage with relatively evenly-distributed, laminar flow under the flume; there would not be any velocity barriers. In addition, there were other areas where Hall Creek passed under the flume with clearance. Photos 1 and 2 portray the flume where it

Hall Creek is passable at all flows. The area that Hall Creek drains is extremely low gradient, and it tends to inundate a wide area laterally. However, Hall Creek does have a main channel and its thalweg where it crosses under the tailrace flume is over 3.0 ft in depth on the date of the survey. With a cross-sectional area of 100 ft², the opening under Hall Creek can easily accommodate fish passage at much higher flows without creating any velocity barriers to fish under these conditions.

Photo 1. Hall Creek upstream of flume.

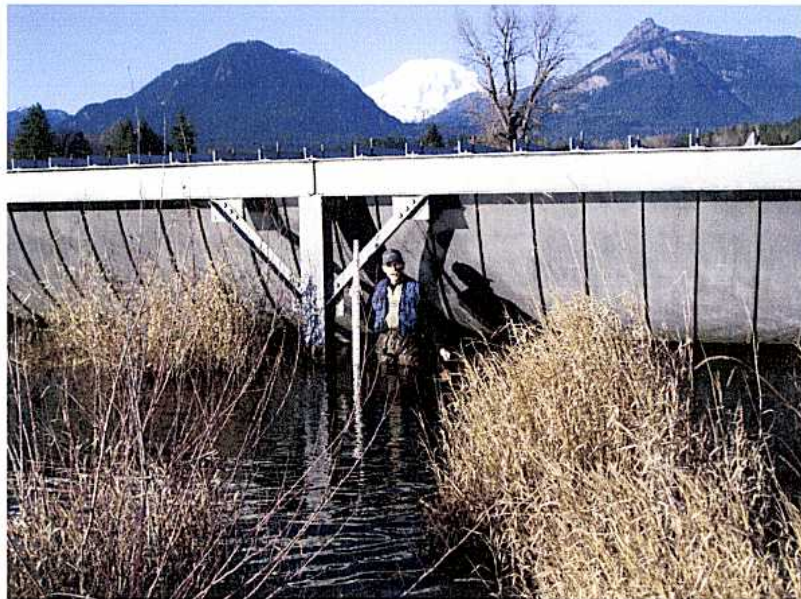
Photo 2. Hall Creek downstream of tailrace flume.

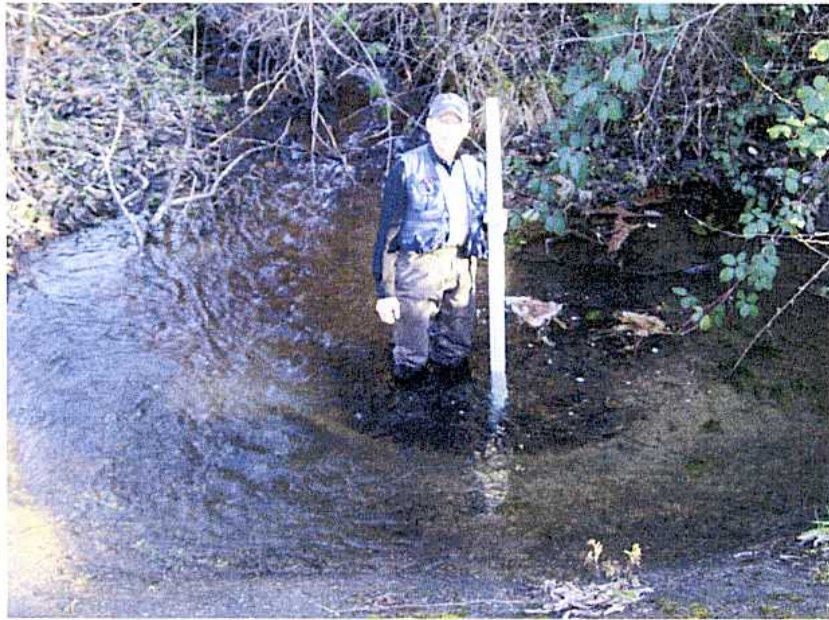
Snyder Creek originates from Snyder Lake and enters a vertical drain on the upstream side of the tailrace (see Figure 1). The drain is covered by a grate, with openings as large as 9.6 in X 6in. At the time of the survey, the grate was covered with 1.23 ft of water (see Photos 3 and 4).

The openings in the grate upstream of the flume vary in size, with the largest ones measuring 9.6 in X 6 in. Openings of this size would probably allow passage of coho salmon. Given the size of Snyder Creek, it is unlikely that Snyder Creek would support Chinook salmon.

Photo 3. Drain at Snyder Creek, upstream side of tailrace.

Currently, it is feasible that coho could swim up Snyder Creek and effectively pass through the culvert and travel upstream through the drain. Energy Northwest staff has seen fish above the drain previously. Passage, however, could be facilitated by: 1) replacing the drain with a new drain cover with bigger openings, and 2) dredging out the culvert. Provided the hydraulic control is maintained downstream, the culvert and drain will stay submerged and passage would be improved. Energy Northwest staff has observed the drain submerged even during summer low flows (R. Crawford, personal communication, December 27, 2004).

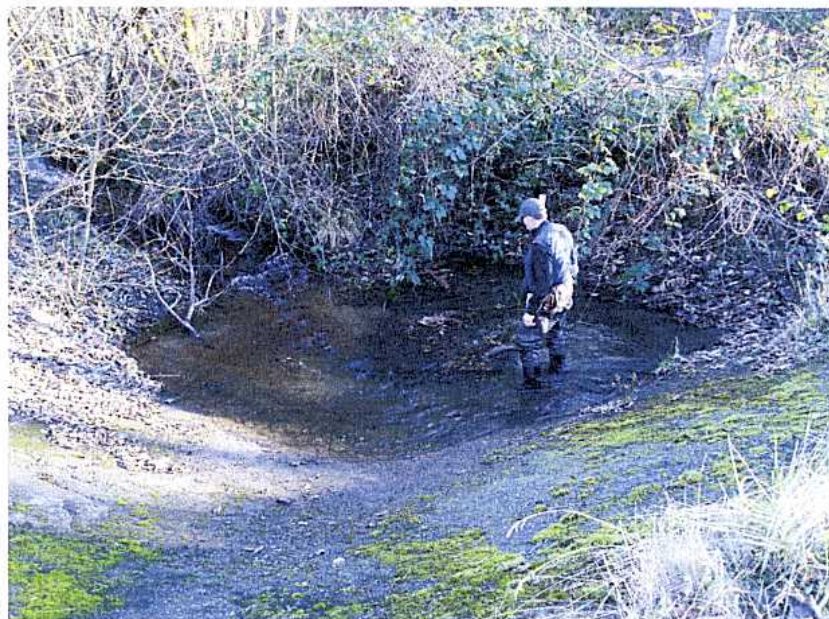
Below the grate, the creek drains vertically 4.65 ft before connecting with a concrete-encased culvert which extends across and underneath the tailrace. The water surface elevation on the upstream side (i.e., above the drain) was only 0.27 ft higher than the downstream side of the drain; a riffle immediately downstream of the culvert opening is the hydraulic control for the opening (see Photos 5 and 6). Figure 1 shows the location of Hall Creek relative to the project powerhouse and tailrace. Figures 2 and 3 show the Snyder Creek drain in plan and profile view, respectively.

Photo 4. Drain and stilling well on Snyder Creek, upstream side of tailrace.

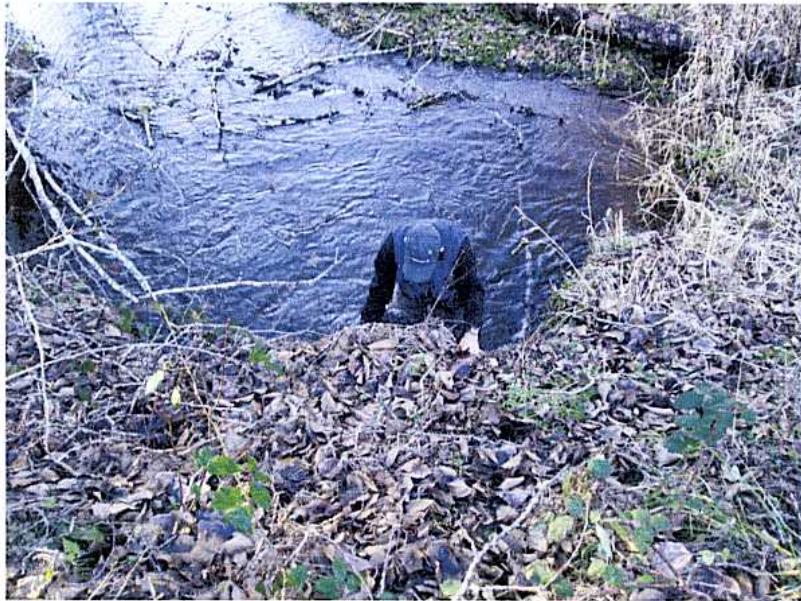
Currently, most of the culvert is filled with sediment passing down Snyder Creek and through the grate. Only the top 6 in – 8 in is currently clear, and all flow is directed towards this top and the opening. A deep pool exists immediately downstream of the crossing with a hydraulic control 0.16 ft below the downstream water surface elevation.

Photo 5. Riffle acting as control for pool, downstream side of tailrace.

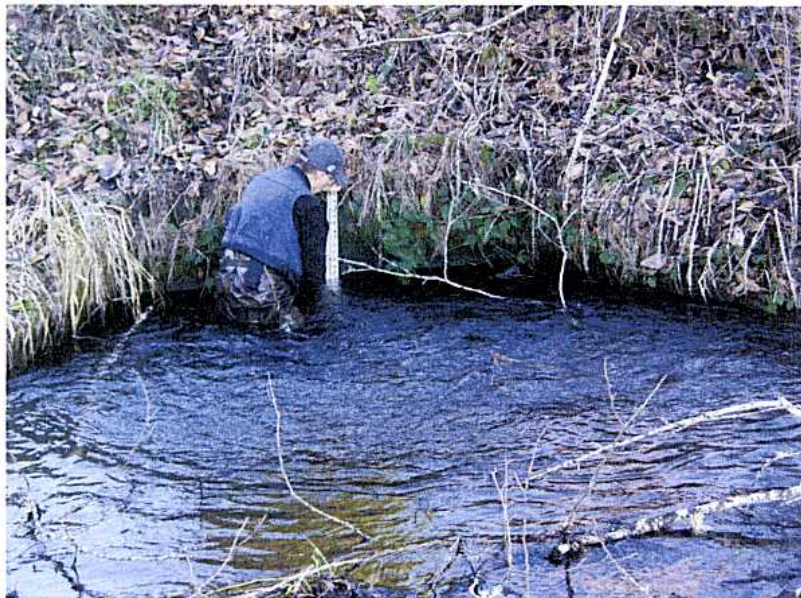
Photo 6. Downstream entrance of culvert on Snyder Creek, below tailrace.

In conclusion, the tailrace flume does not impede fish passage at Hall Creek. Fish passage is currently possible in Snyder Creek; however, passage could be improved at minimal expense by unplugging the culvert and replacing the current drain cover on the upstream side of the tailrace channel.
