***Avian Protection Plan***

**Energy Northwest's  
Packwood Lake Hydroelectric Project  
FERC No. 2244  
Lewis County, Washington**

**June 2008**

**PACKWOOD LAKE HYDROELECTRIC PROJECT  
AVIAN PROTECTION PLAN**

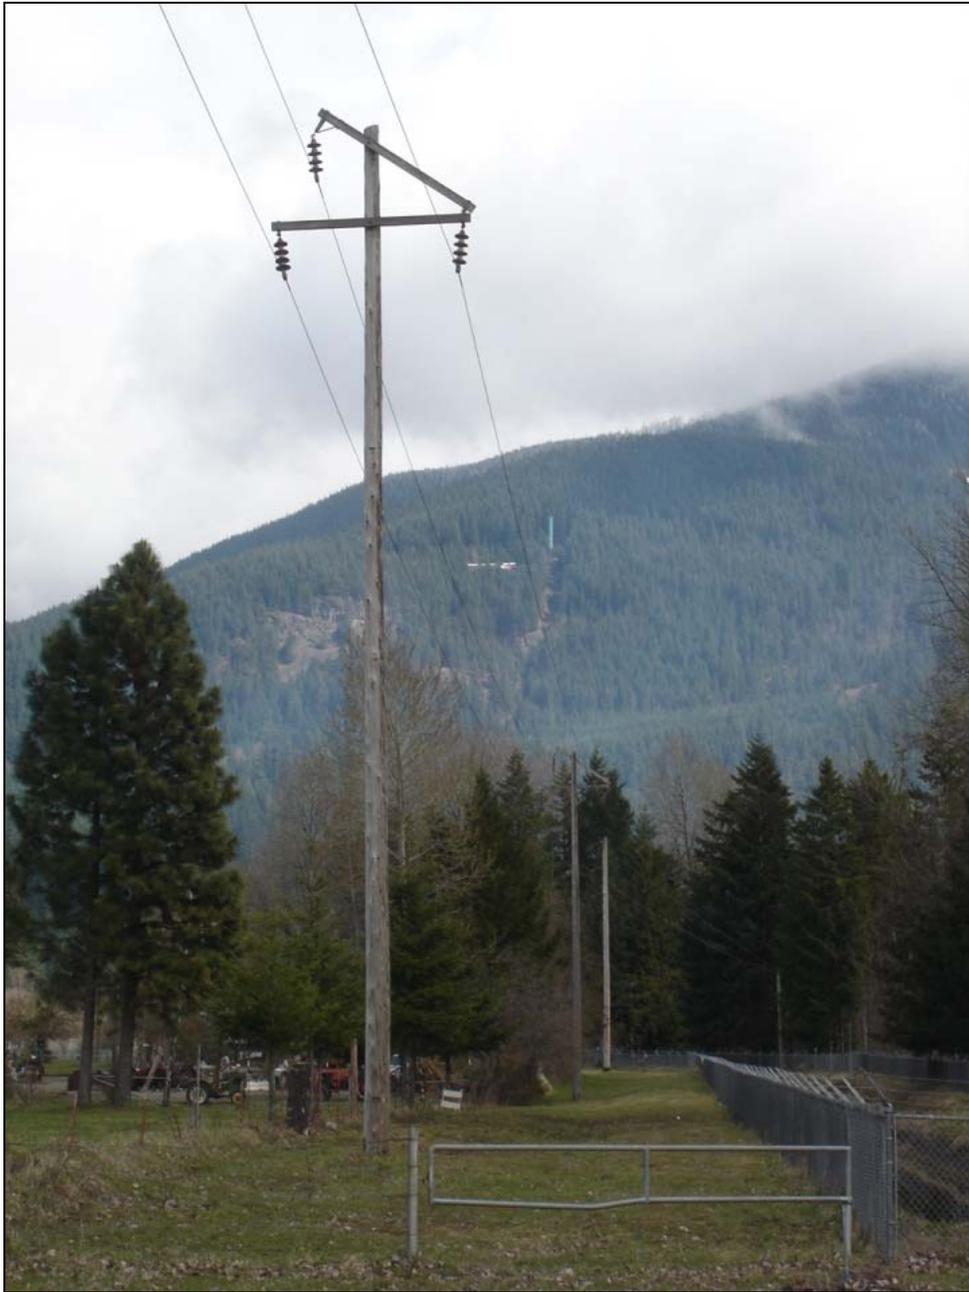
**Figure 2. Transmission line adjacent to project tailrace canal, showing wishbone conductor configuration.**

Drawings of the wishbone and vertical, phase opposite designs are included (Appendix 1). The designs appear to conform to accepted standards for electrocution risk avoidance (i.e., adequate distance between phase conductors and between the phase conductors and a grounding source line), and are not equipped with overhead ground wires. Drawings of the vertical arrangement employed at turning points are not available. The conductor arrangements on the Project transmission line are not known to be hazardous to birds. Lewis County PUD has not experienced bird-related outages or known avian electrocutions with these designs, and the Project operators have not documented any bird collisions or problems.

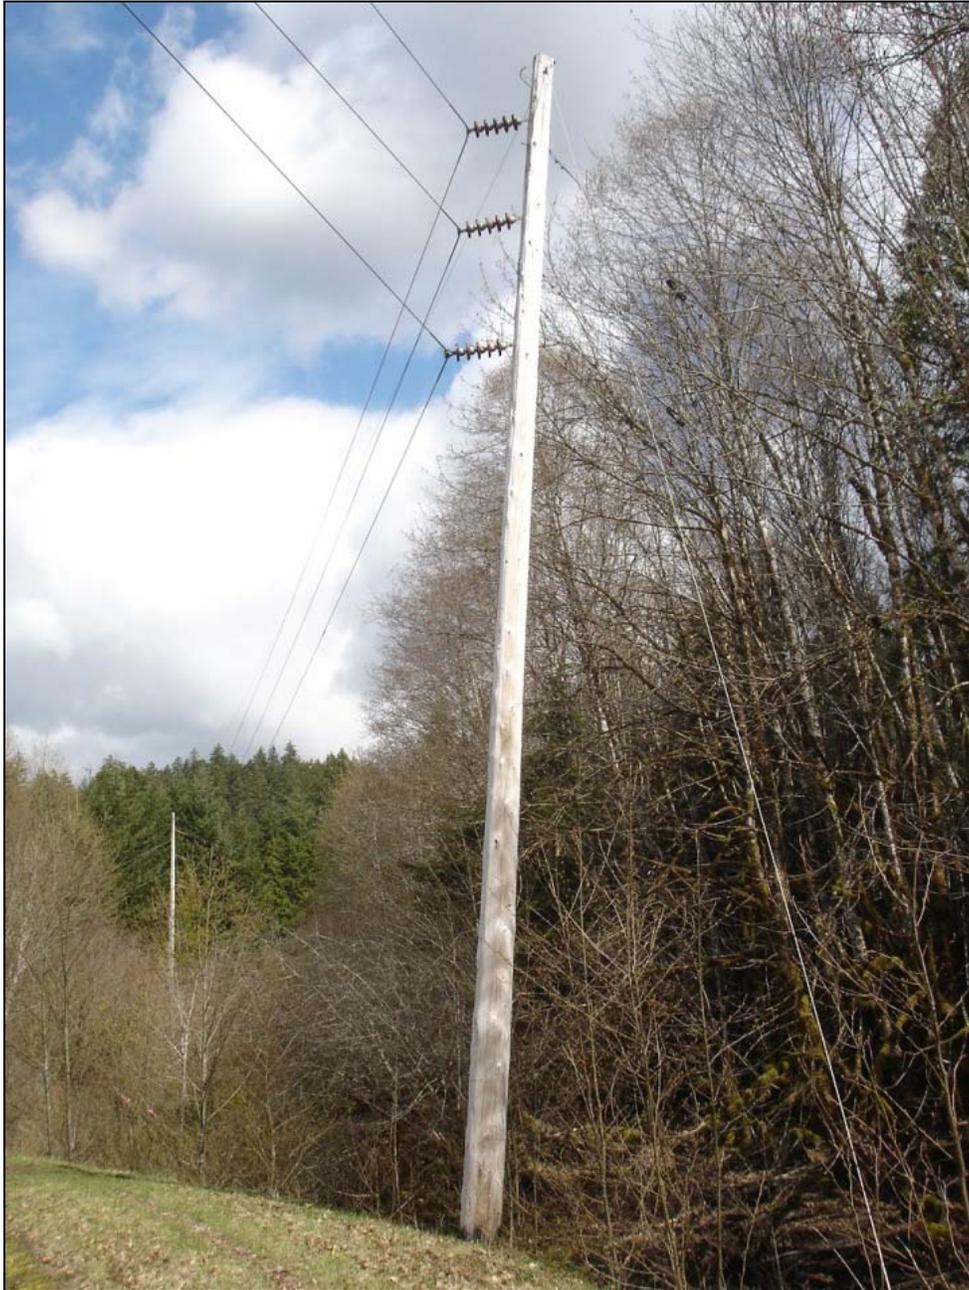
**Figure 3. Vertical conductor design used between the powerhouse and Highway 12.**

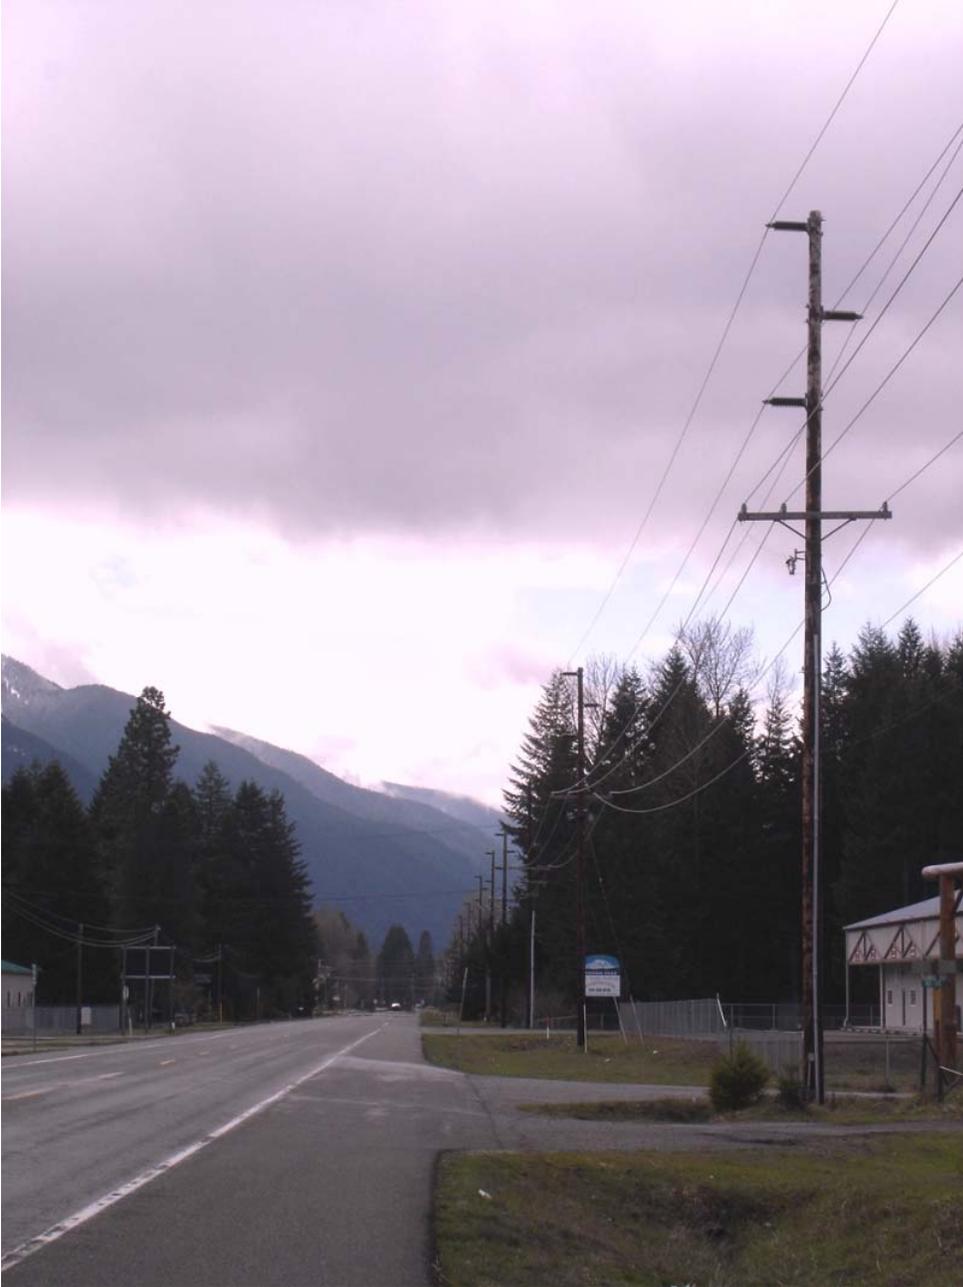
**Figure 4. Vertical conductor design used along Highway 12.**

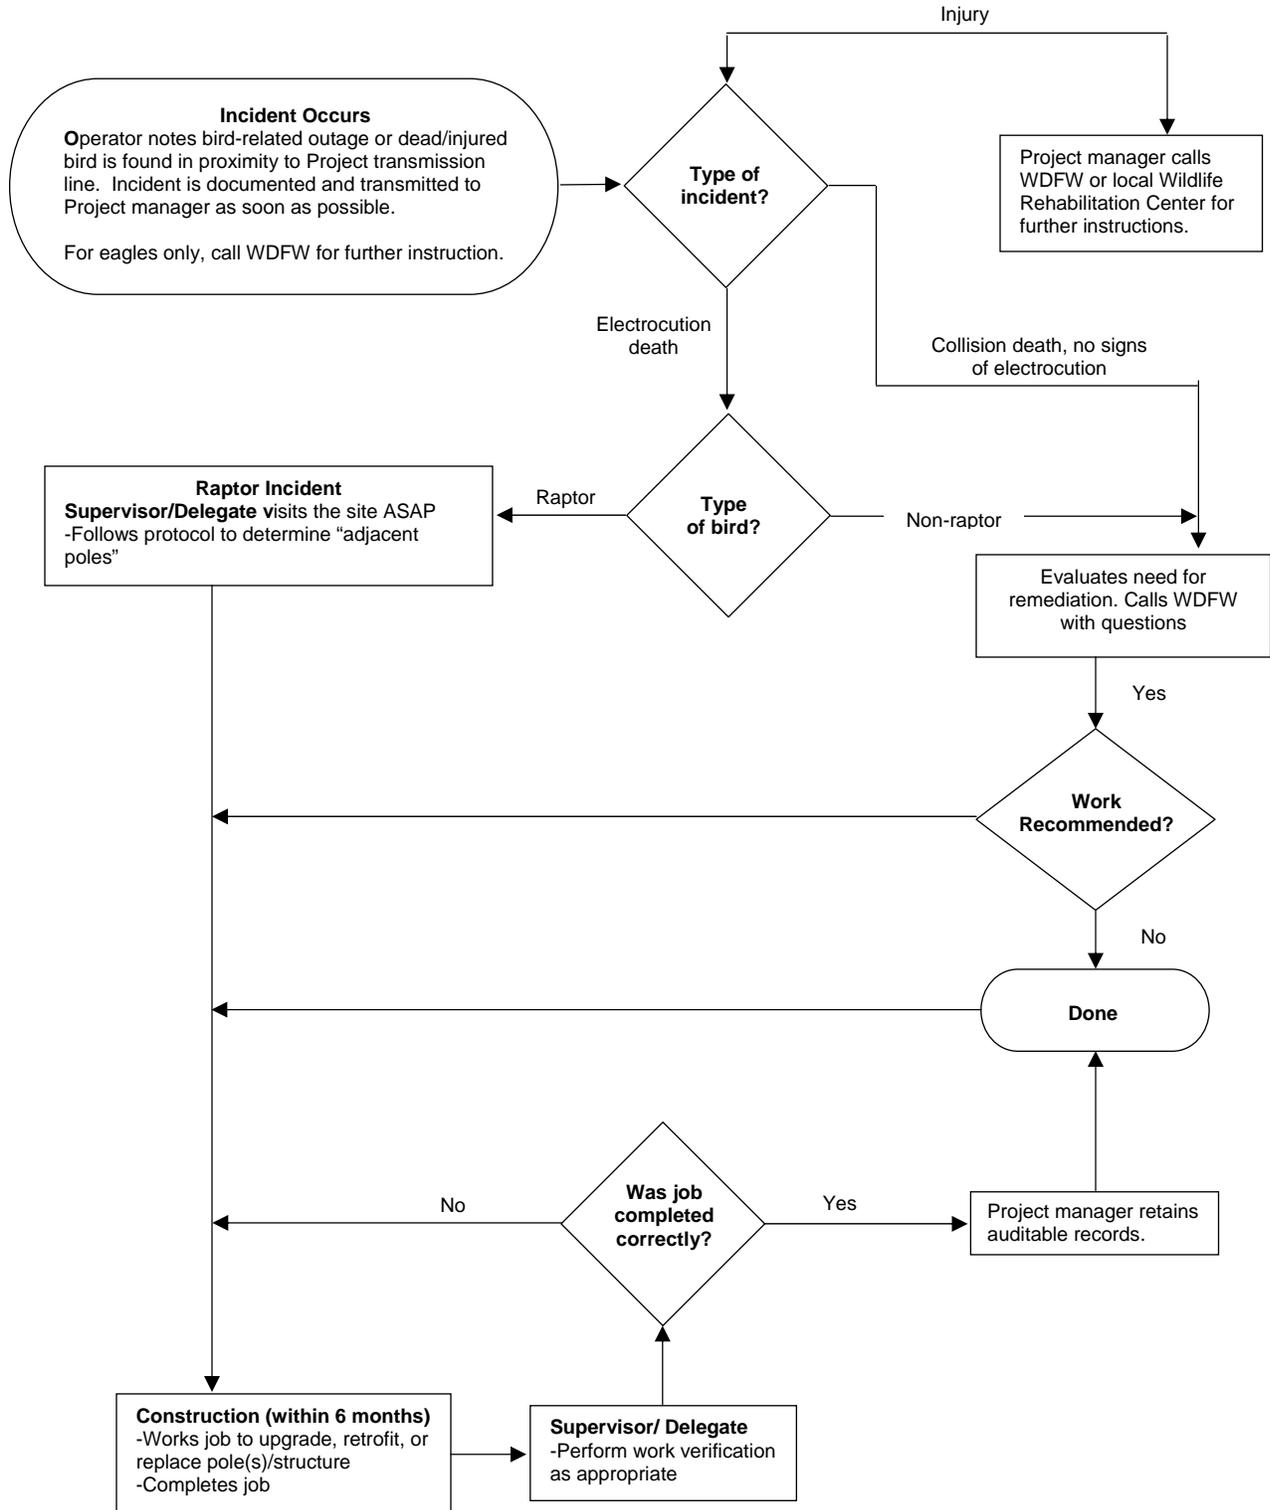
Figure 5. Avian Incident Response Work Flow Diagram

If any Project transmission line structure is involved in a bird fatality or injury, Energy Northwest will evaluate the need for and feasibility of rebuilding or retrofitting structures to avoid or minimize future risk. Energy Northwest will follow an incident response process (Figure 5) similar to that used by other utilities and consistent with APLIC (2005) recommendations. Any rebuilding or replacement of the transmission line structures will be made to current APLIC configuration standards.

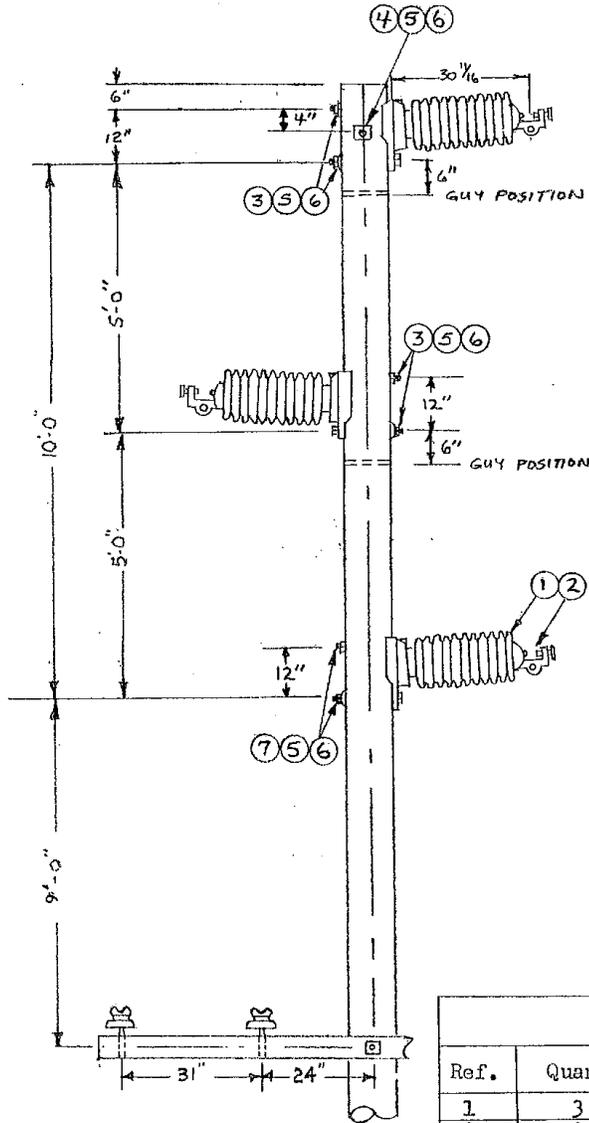
N-21

Note:  
 (a) 800# maximum design side angle loading.

115 KV CONSTRUCTION - - HORIZONTAL POST 0° - 7°

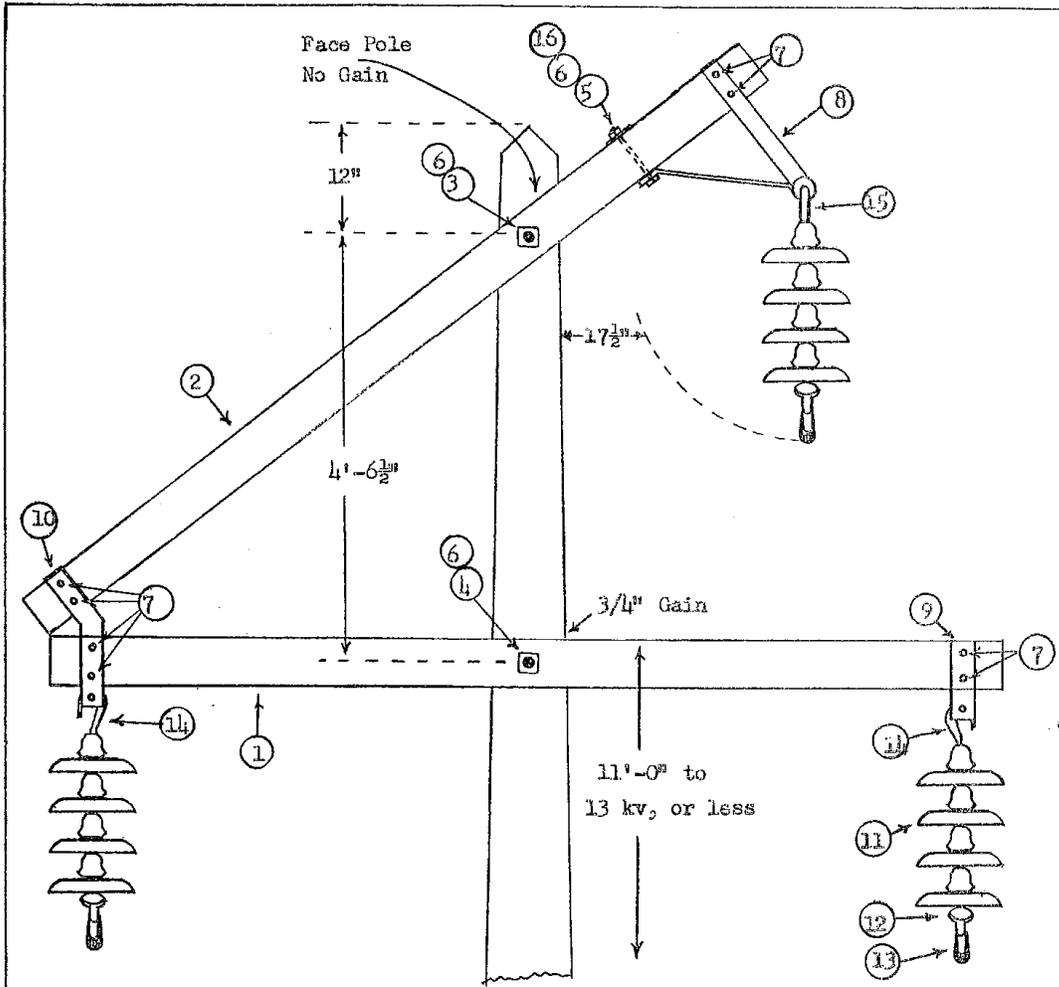
Note:  
 (a) The open side of the wishbones should face toward the center of the angle.  
 (b) On tangents the open side of the wishbone should be on the street side.

69 KV. HEAVY DUTY WISHBONE CONSTRUCTION OVERHEAD LINE STANDARDS PUBLIC UTILITY DISTRICT #1, LEWIS COUNTY	1 of 2 3 - 2
--	-----------------
