PRELIMINARY DRAFT
**HALL CREEK AND SNYDER CREEK
FISH PASSAGE**

Prepared for:
Energy Northwest

Prepared by:
EES Consulting

January 2005

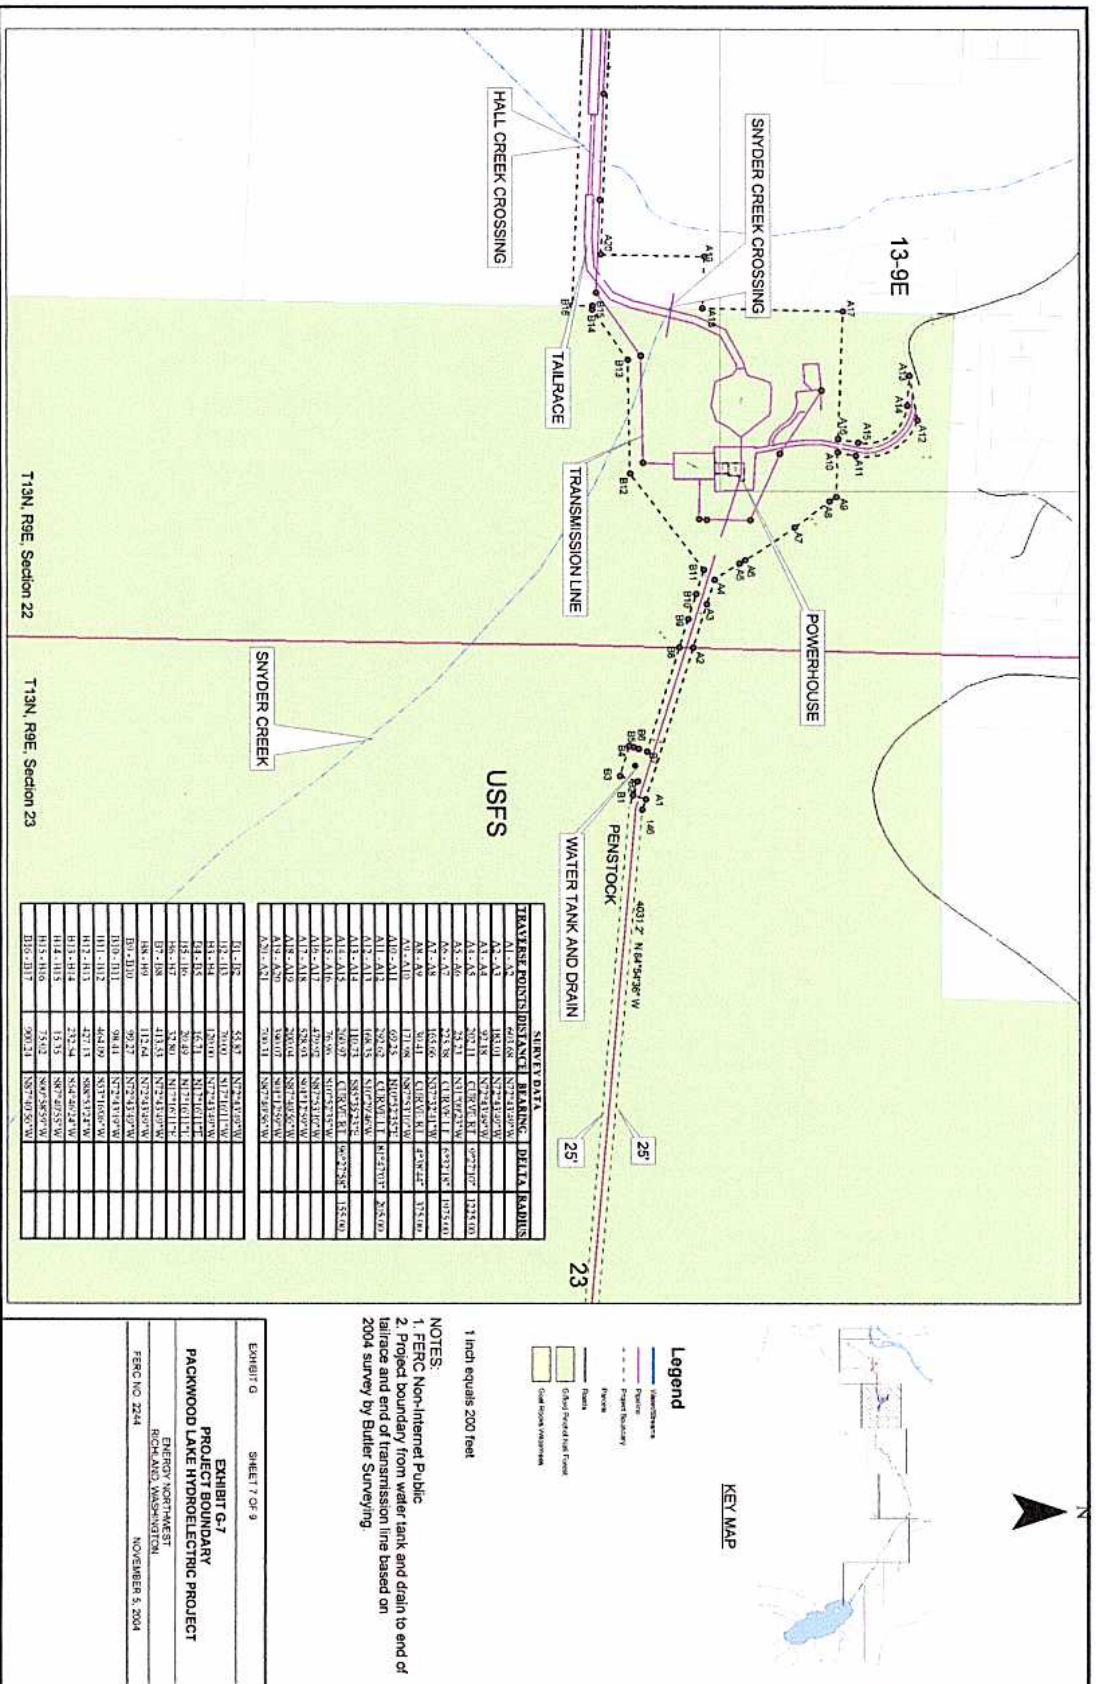
Figure 1 – Snyder Creek and Hall Creek Stream Crossings

Both Hall Creek and Snyder Creek cross under the tailrace (see Figure 1). Snyder Creek enters a vertical drain in a stilling basin on the upstream side of the tailrace; it exits via a horizontal culvert encased in concrete on the downstream side into a small basin attached to a channel that eventually drains into Hall Creek. The tailrace flume is suspended for 360 ft over Hall Creek, which passes underneath the flume in a marshy area.

spans Hall Creek. Figure 1 shows the location of Hall Creek relative to the project powerhouse and tailrace.

Snyder Creek originates from Snyder Lake and enters a vertical drain on the upstream side of the tailrace (see Figure 1). The drain is covered by a grate, with openings as large as 9.6 in X 6in. At the time of the survey, the grate was covered with 1.23 ft of water (see Photos 3 and 4).
