# **Study Update**

## Fish Distribution and Species Composition

# Goals and Study Area

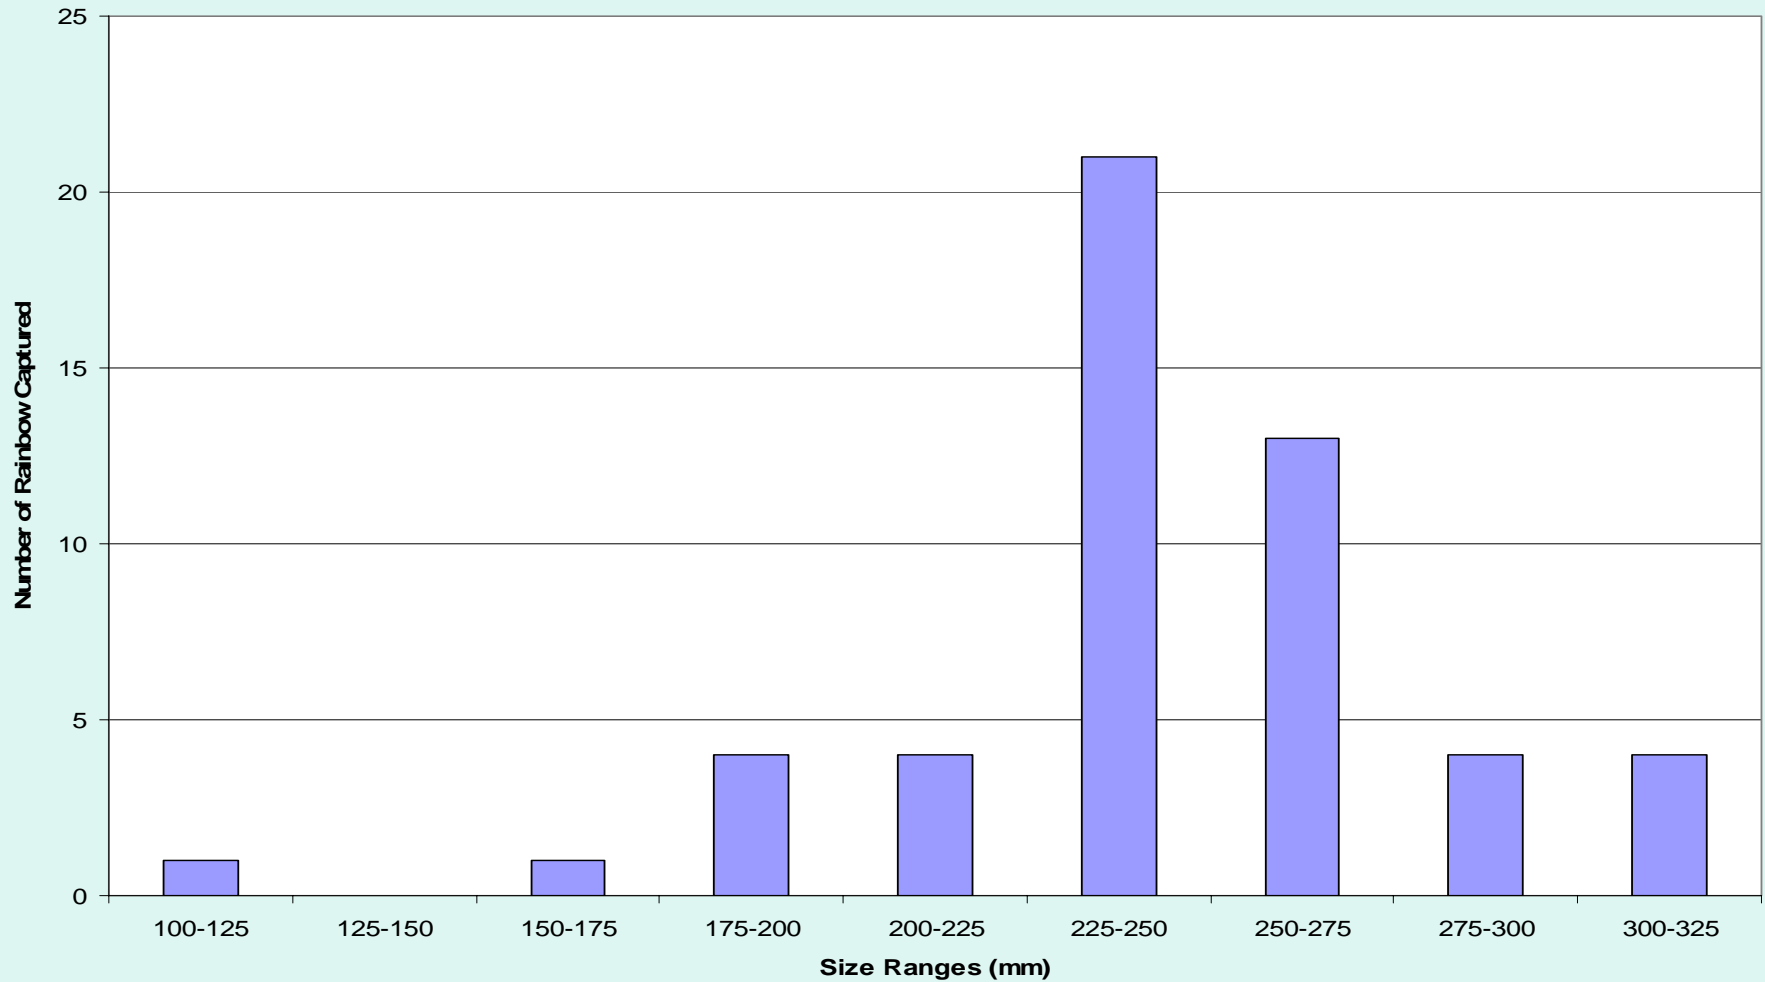
# Length Distribution of Fish Captured in Packwood Lake Near Osprey Creek

**Netting at Osprey Point  
(52 Total Rainbow Captured)**

- Two net sets were done on Packwood Lake using 2 vertical and 2 horizontal floating gill nets
  - May 2<sup>nd</sup> and 3<sup>rd</sup>, 2006 (Overnight)
  - July 19, 2006
- Two nets were placed in approximately 15 ft of water off of the mouth of Osprey Creek
- Two nets were placed in approximately 20 ft of water off of the mouth of Upper Lake Creek
  - 52 rainbow were captured in the nets in front of Osprey Creek
  - 53 rainbow were captured in the nets in front of Upper Lake Creek

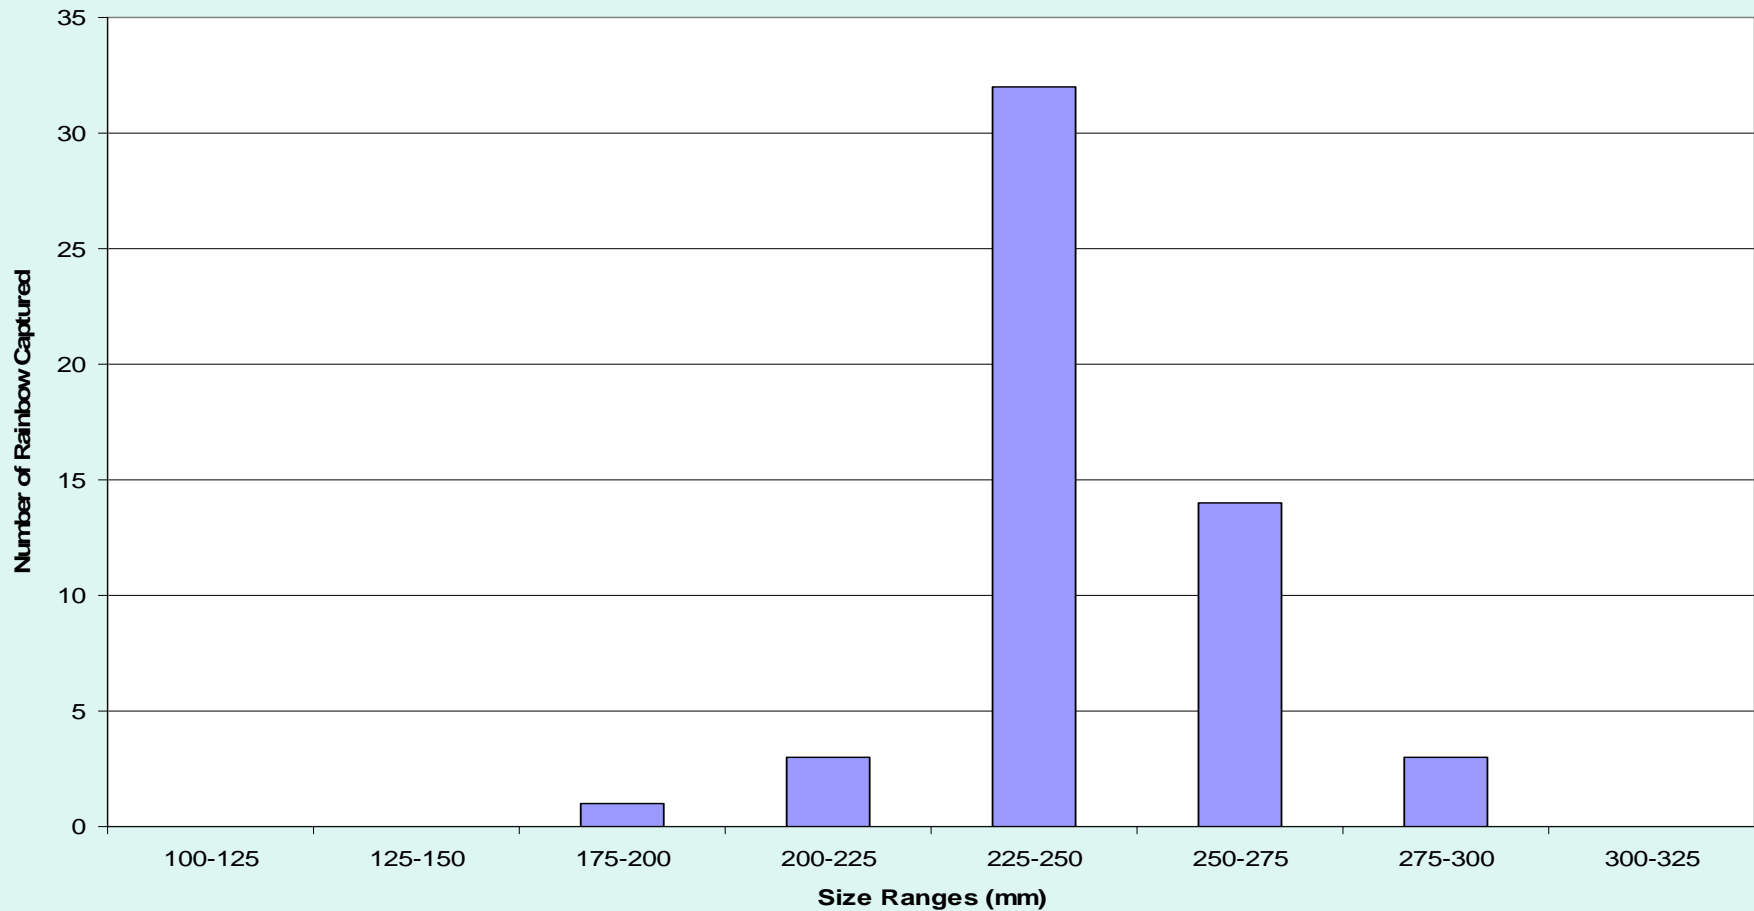
# Length Distribution of Fish Captured in Packwood Lake Near Upper Lake Creek

Upper Packwood Lake Netting  
(53 Total Rainbow Captured)

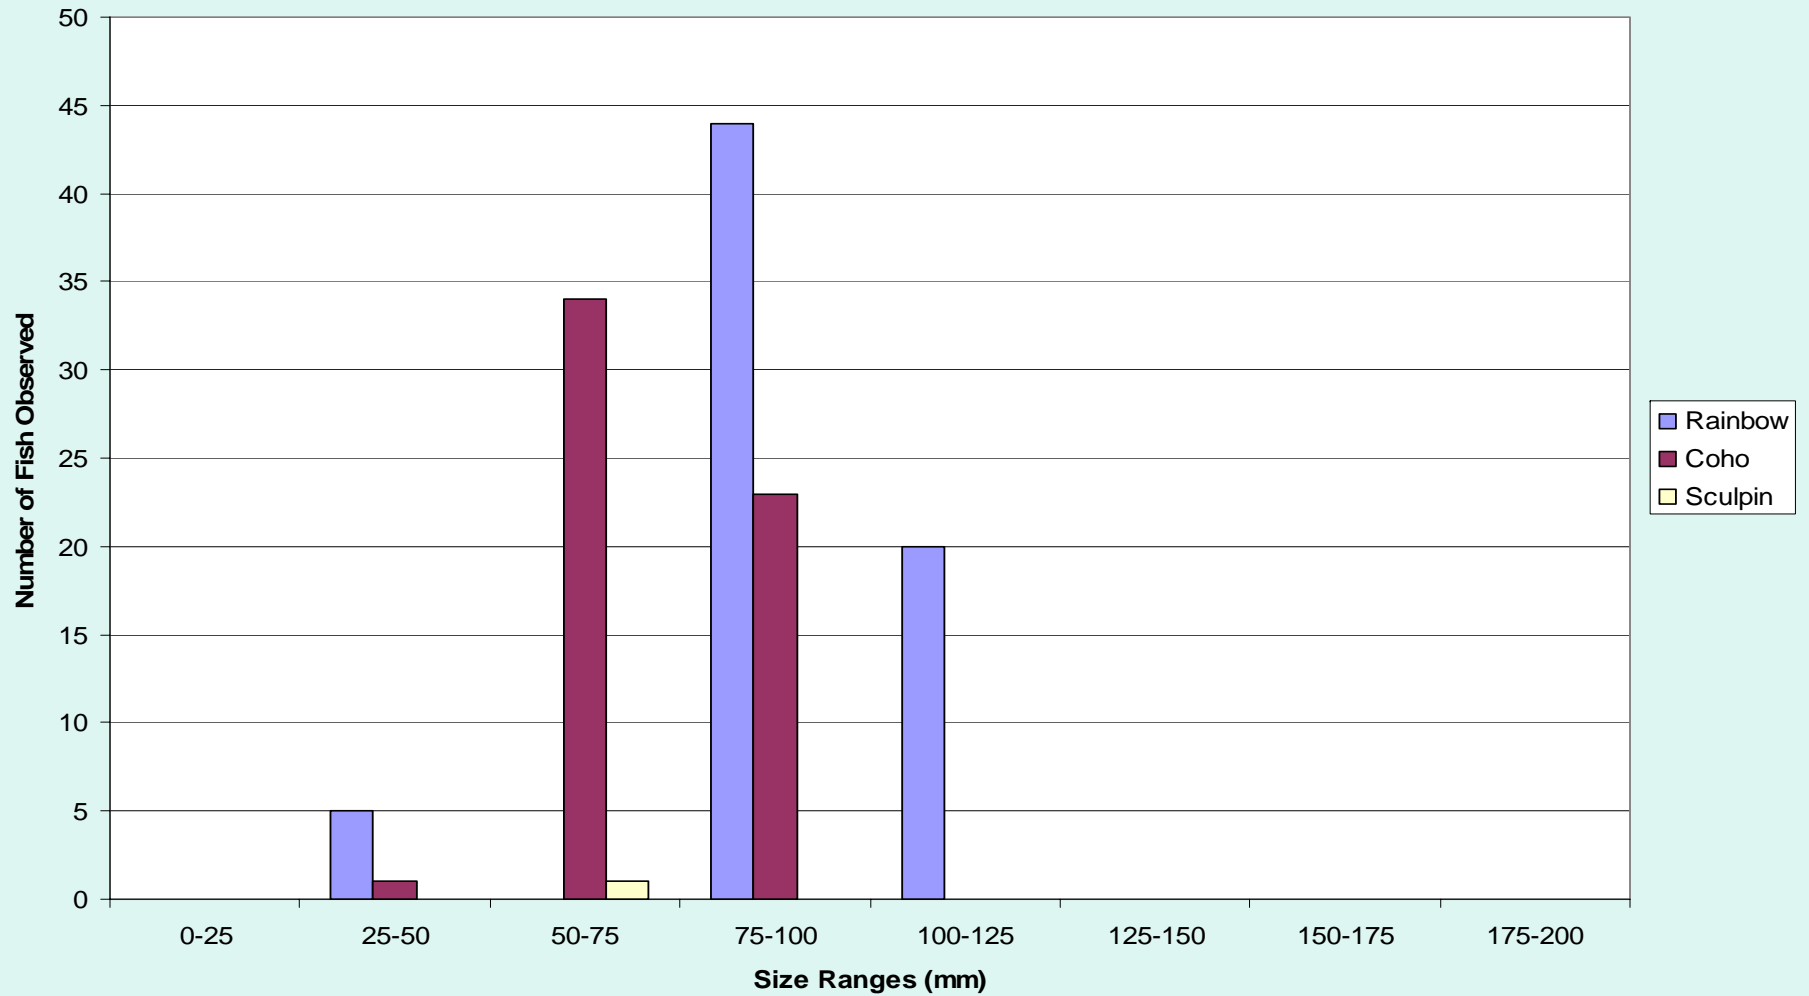
# RM 0.0-1.0 (Snorkel)

Fish Snorkeling Observations for Lake Creek  
(RM 0.0-1.0)

- 5.4 miles of lower Lake Creek was surveyed using a combination of snorkeling and electrofishing techniques
- The nearly 0.4 miles of Snyder Creek above the crossing with the tailrace was electrofished
- Fish species distribution and composition data was collected
- The same habitat characteristics described above were documented also

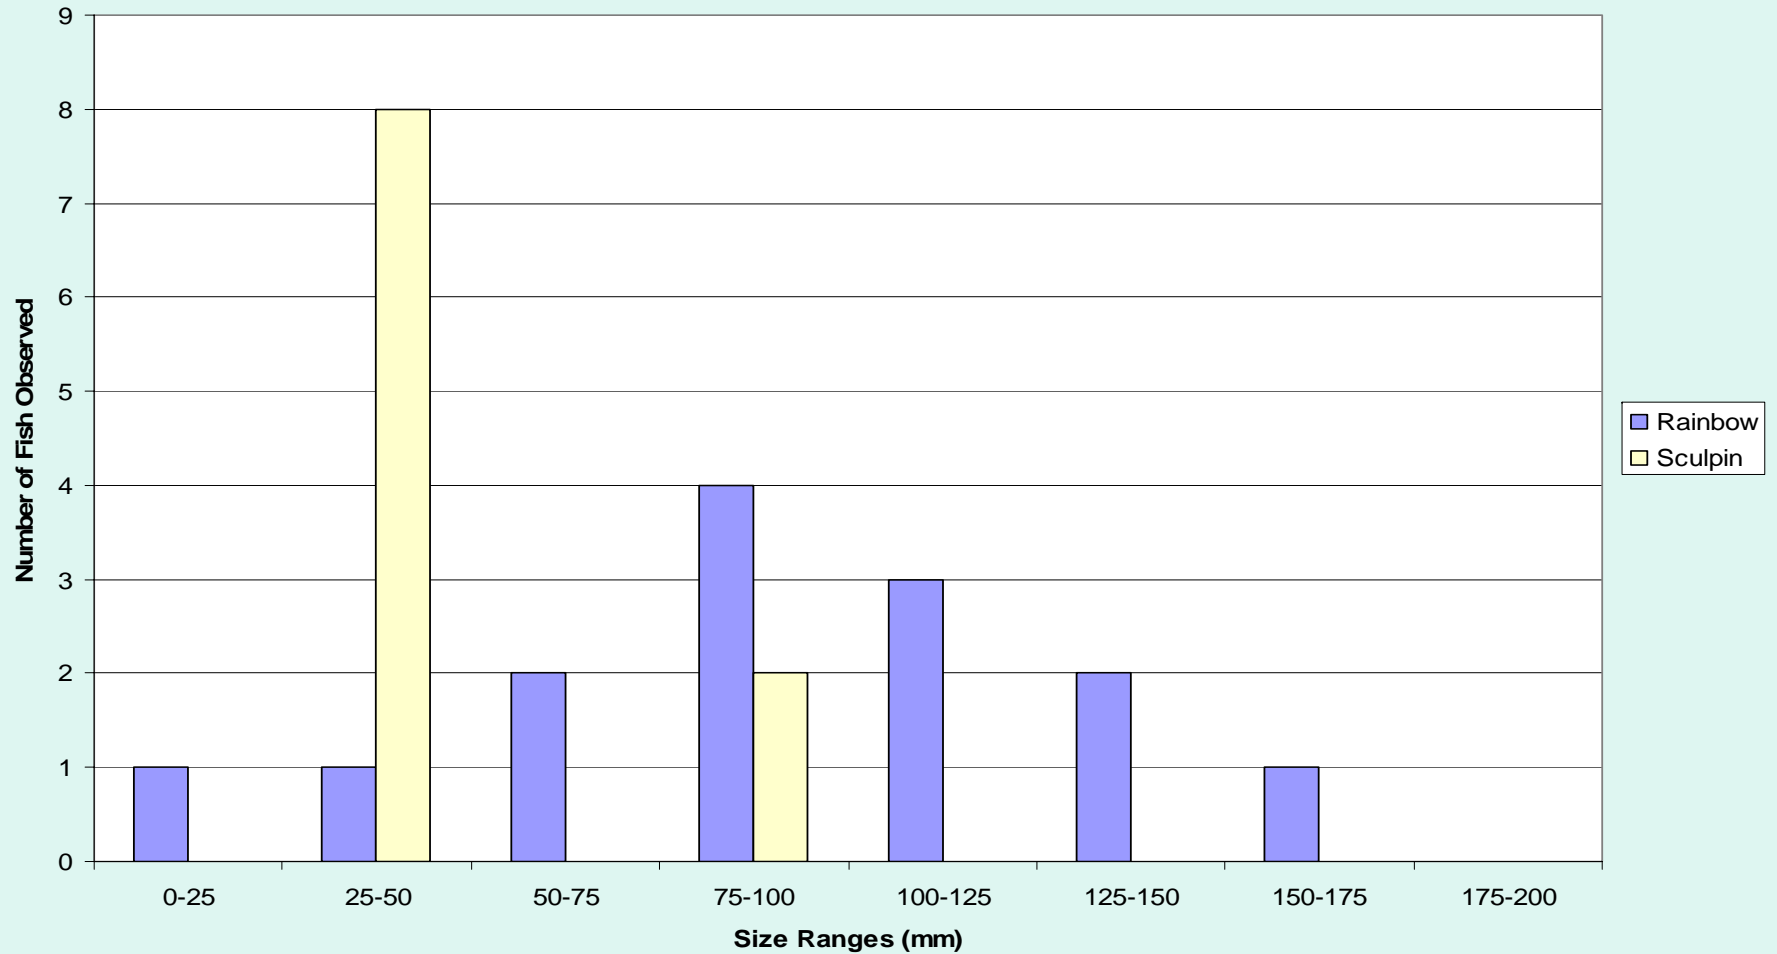
# RM 1.0-1.9 (Electrofishing)

Fish Shocking Observations for Lake Creek  
(RM 1.0-1.9)

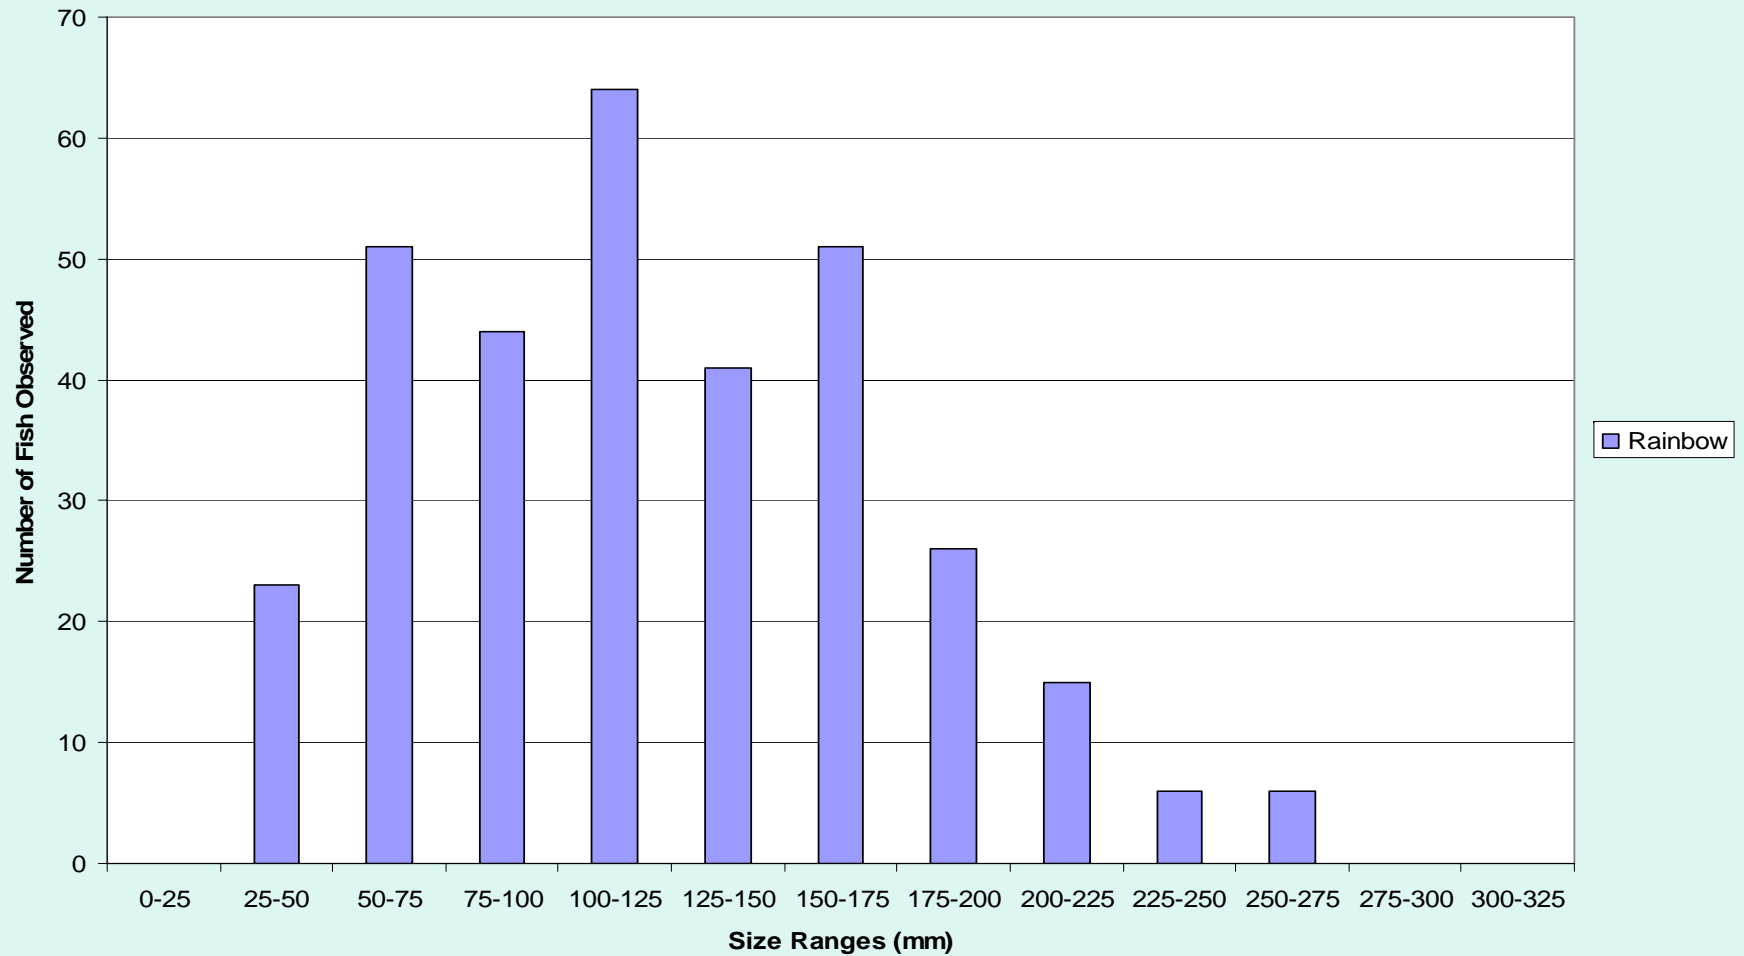
# RM 1.9-5.17 (Snorkel)

Fish Snorkeling Observations for Lake Creek  
(RM 1.9-5.17)

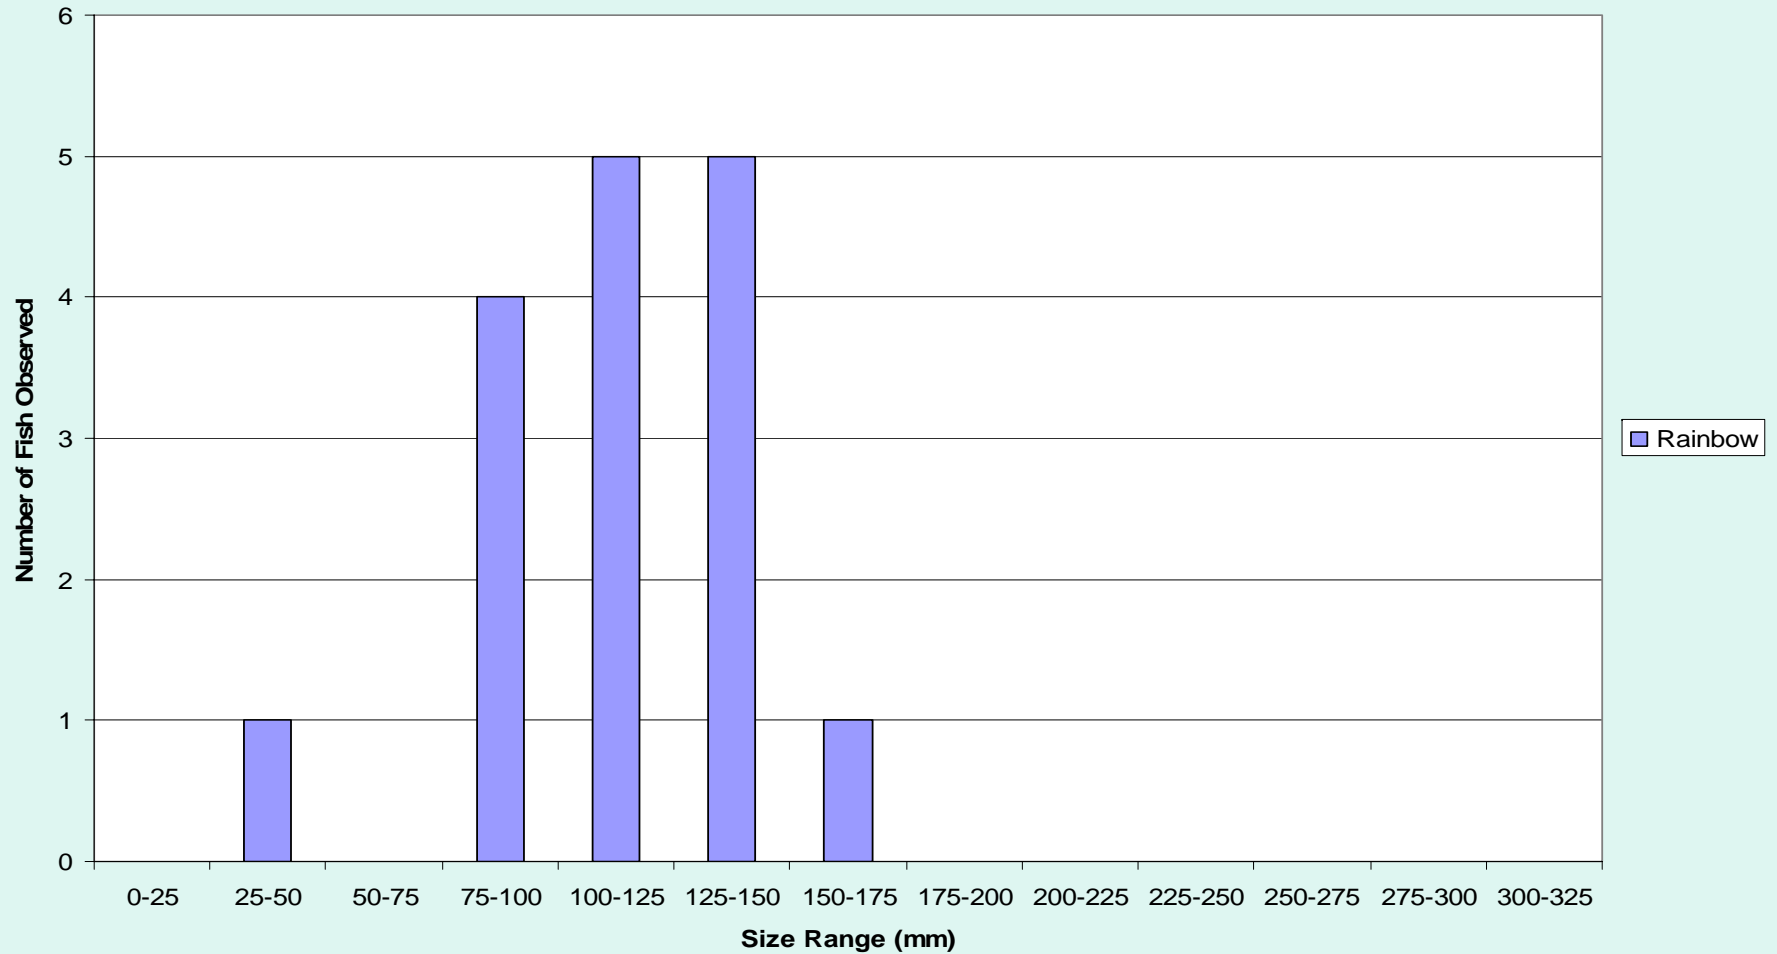
# RM 5.17-5.4 (Electrofishing)

Fish Snorkeling Observations for Lake Creek  
(RM 5.17-5.4)

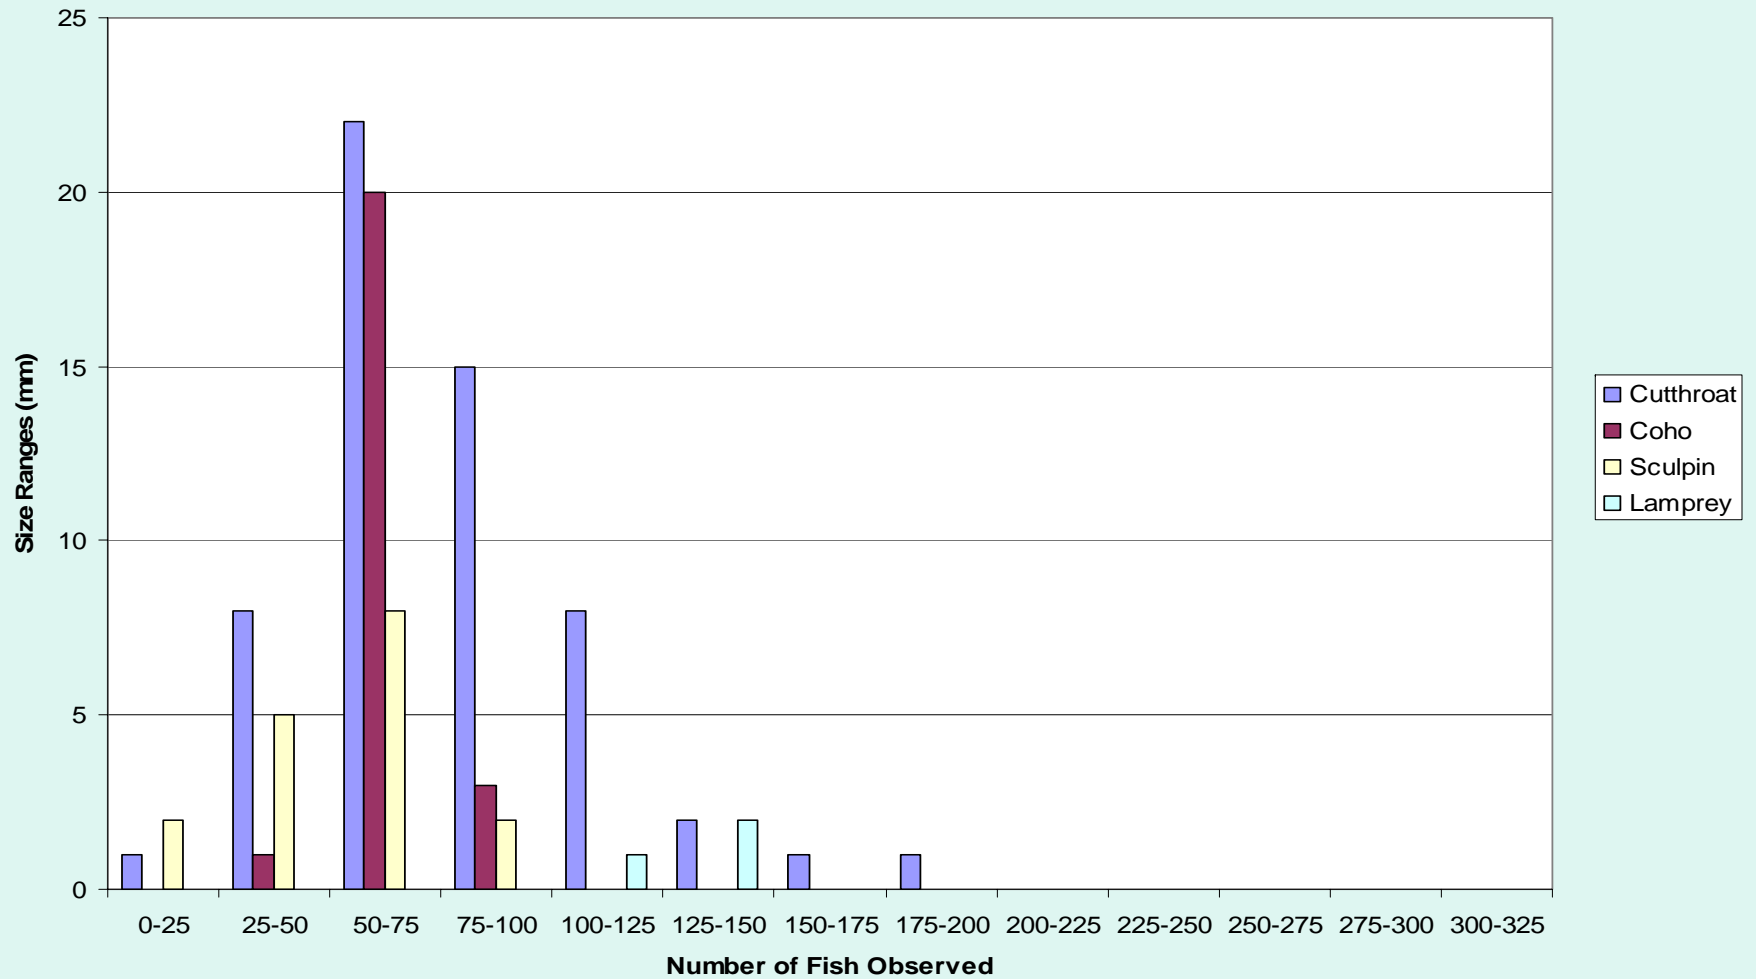
# Snyder Creek (Electrofishing)

Fish Shocking Observations for Snyder Creek
